Manhole Inspection Summary

Manhole # S39WW_037MH

Insp Date: **12/25/06 11:12 AM**

Location Address: **954 HOMESTEAD AVE**

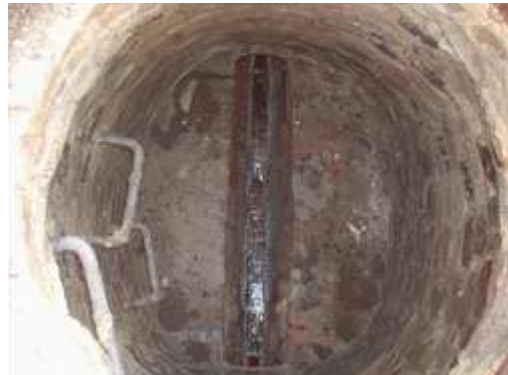
Top View

Bench ☒ Exists Material: **Brick** ☐ Parged ☒ **Debris** (not Condition related)

Bench debris.

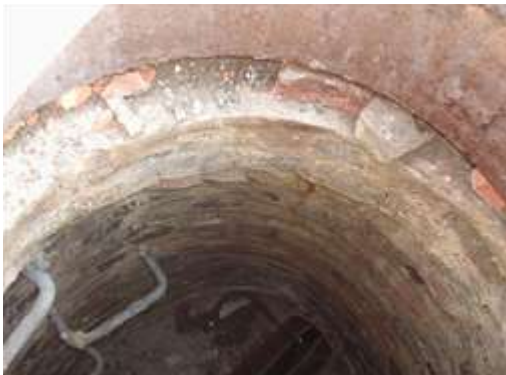
Defect

Frame Offset: **5** (in.) Condition: ☐ Sound ☐ Cracked ☒ **Leaks**

Condition: ☐ Sound ☐ Cracked ☐ Root Intrusion ☒ **Loose Brick** ☒ **Deteriorated**

Infiltration: ☐ None ☒ **Joint** ☐ Cracks ☐ Mortar ☐ Roots ☒ **Wall**

Frame leaks. Frame offset. Adjustment deterioration, loose brick and infiltration.

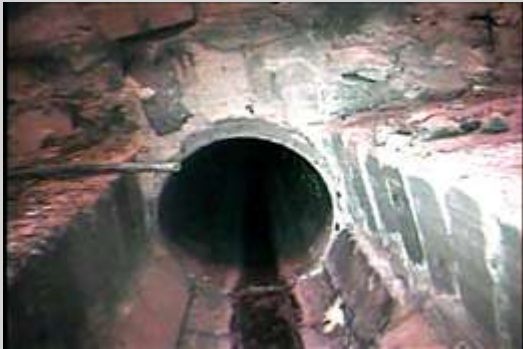
8 in. Circular Gravity Sewer Pipe Out @ 12 O'Clock

Infiltration: **Evidence** Pipe Seal Cond: **Unknown**
